# Vehicle History Report

Chassis number <sup>1</sup>: RK5-1215182

Make: HONDA

Model: STEPWGN

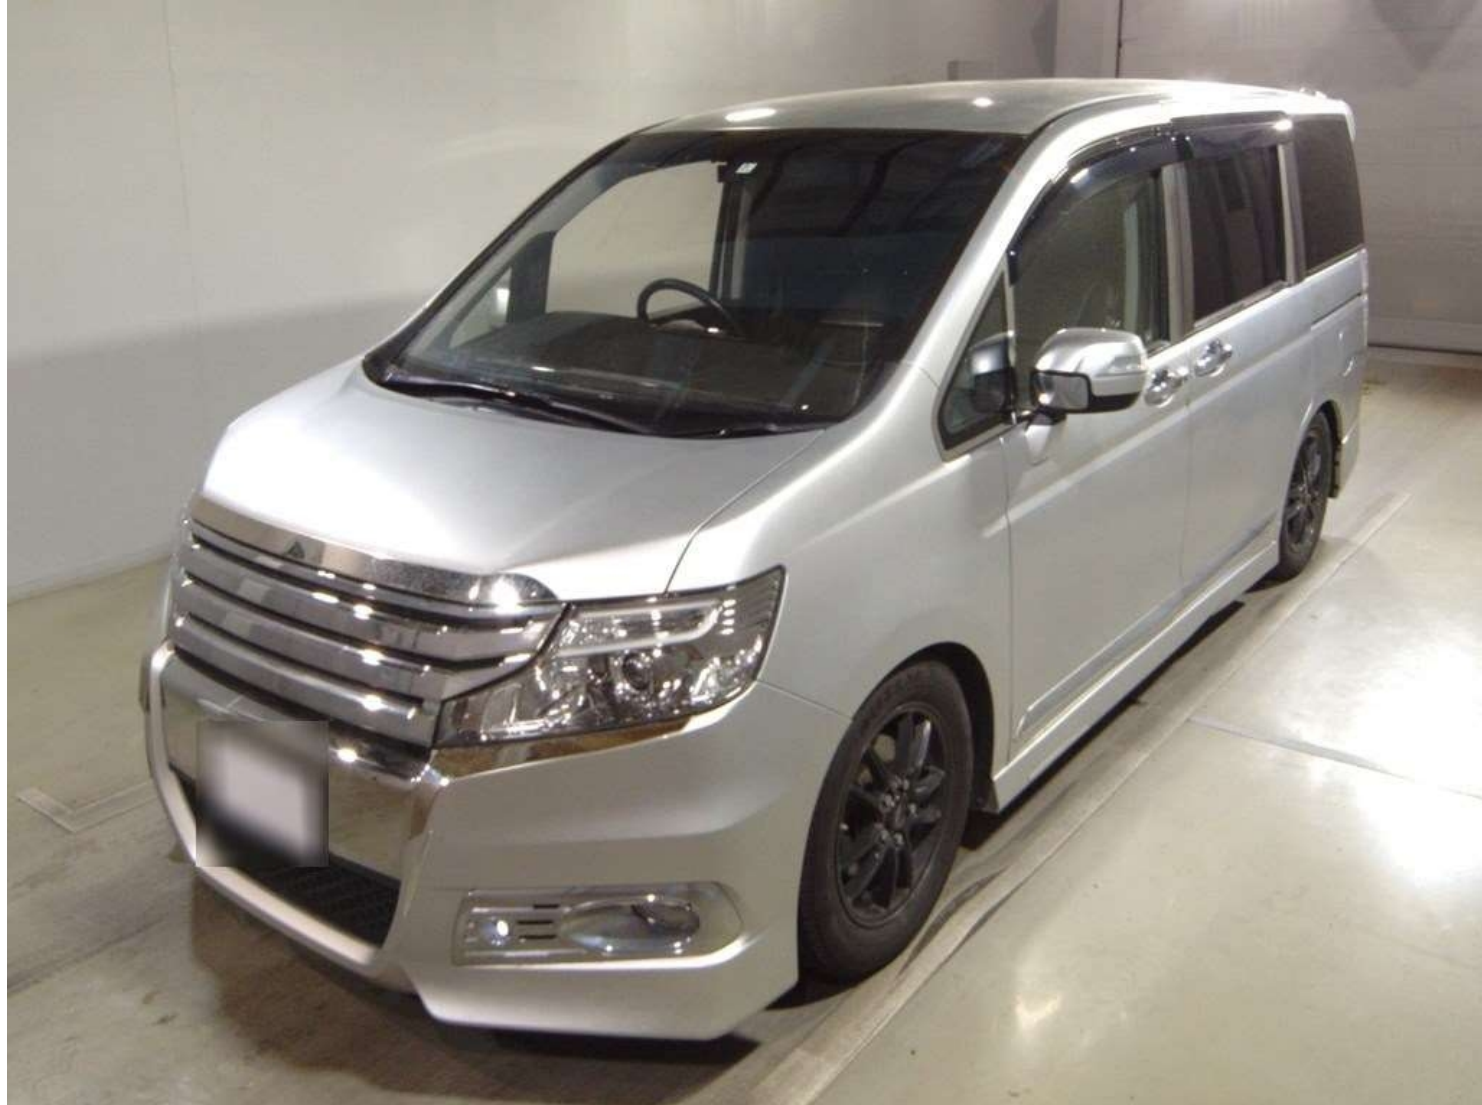
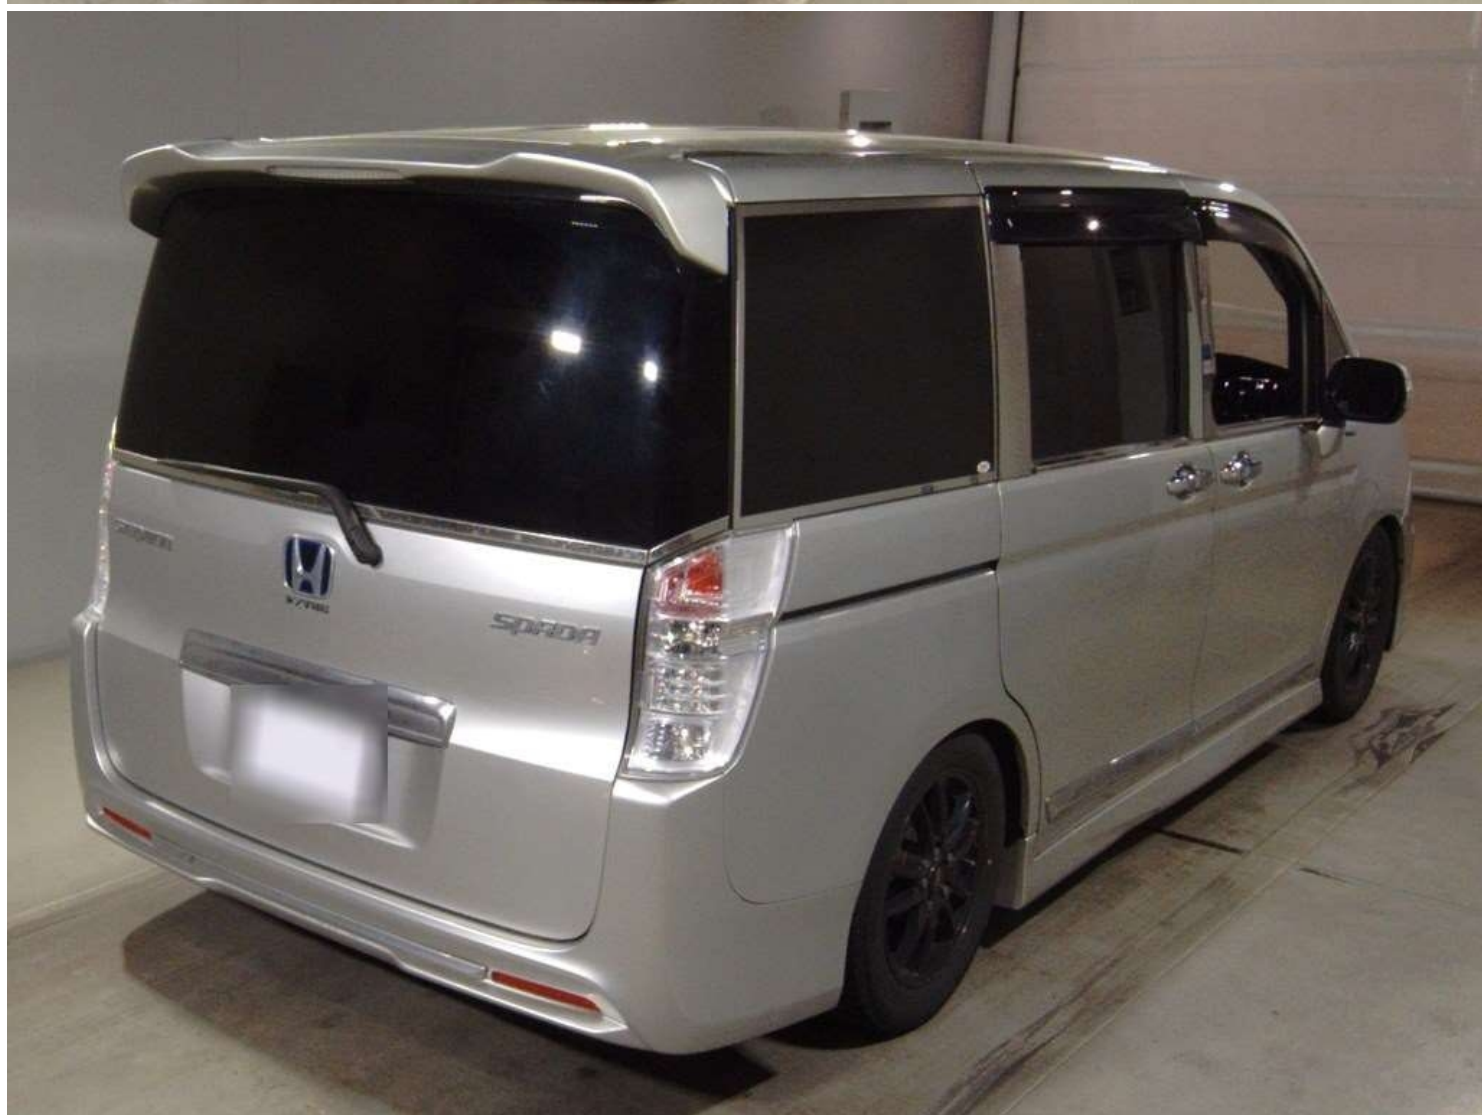
| 検査員記入欄 | |
|---|---|
| エンジン廻りオイル漏れ<br>下廻りS<br>外装のり付<br>下廻りAU<br>室内内張のり付<br>ハンドルすれ<br>シートへたり<br>室内汚れ<br>フロントバンパー押され<br>リヤバンパー押され<br>PW不良(左後)<br>警告灯点灯<br>ガラスフィルム張<br>ローダウン<br>スタッドレスタイヤ<br>外装ペイント跡有<br>社外アルミホイール<br>下廻りP跡 | <p>The diagram is a top-down view of a car's body. It shows various inspection points labeled with codes: A1 (multiple locations on the front, sides, and rear), A2 (on the front fenders), B1 (on the rear side), B4 (on the rear side), G (on the front hood), U1 (on the front bumper), P2 (on the front bumper), and [3] (on the front and rear wheel arches). The diagram is used to record the condition of these parts during an inspection.</p> |

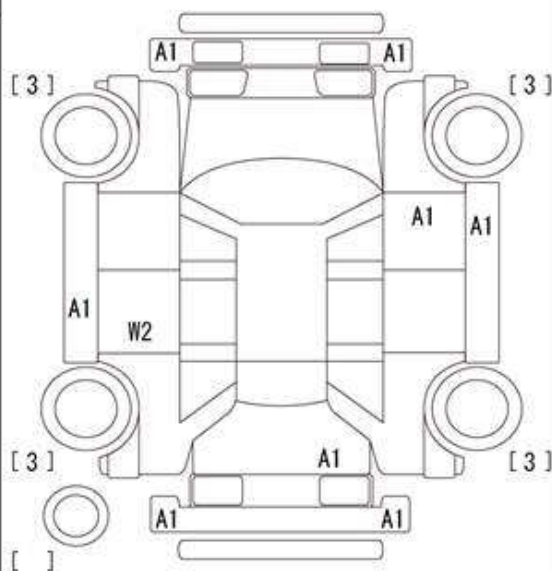
| セールスポイント | 特記事項・不具合箇所 |
|---|---|
| ★純正ナビ★TV (フルセグ)<br>★両側パワースライドドア<br>★バックモニター★ETC<br>★スマートキー<br>★社外アルミホイール<br>★フリップダウンモニター | シートカバー付<br>スタッドレスタイヤ<br>内装汚れ<br>内張り傷<br>シート擦れ<br>ハンドルすれ<br>カーペットすれ |
| ★社外アルミ | |
