Vehicle History Report

Chassis number ¹: HA9-1007865

Make: HONDA

Model: ACTY TRUCK

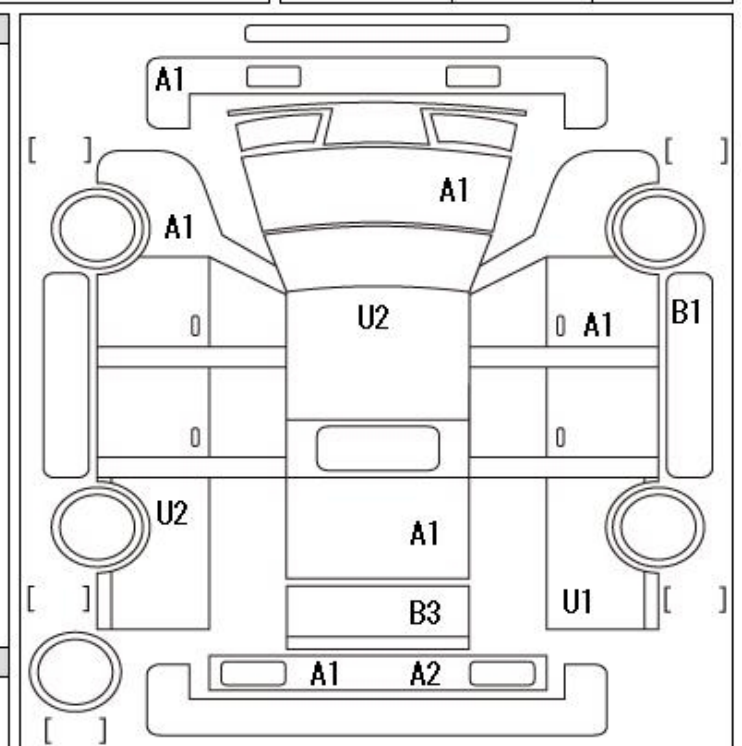
検査員記入欄
下廻りS 外装色あせ スタッドレスタイヤ
事務局よりご案内
