# Vehicle History Report

Chassis number <sup>1</sup>: RK5-1215182

Make: HONDA

Model: STEPWGN

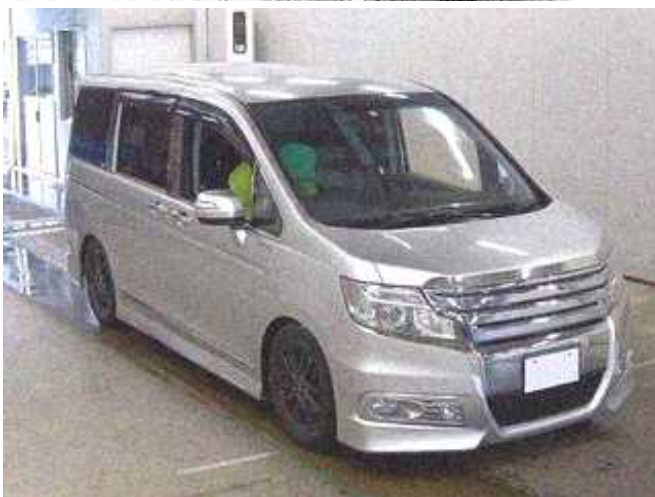
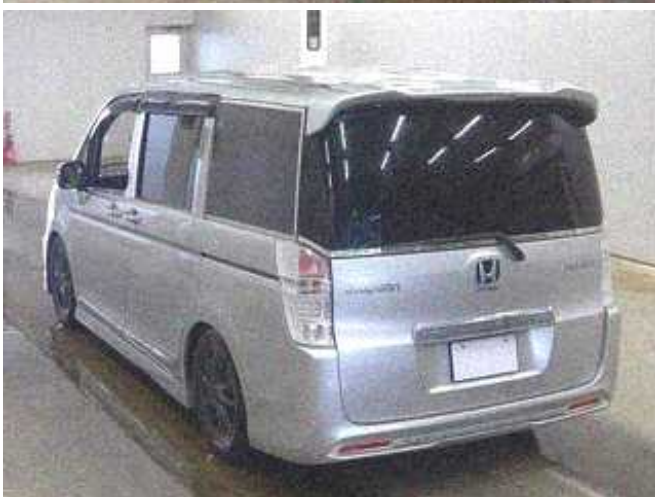
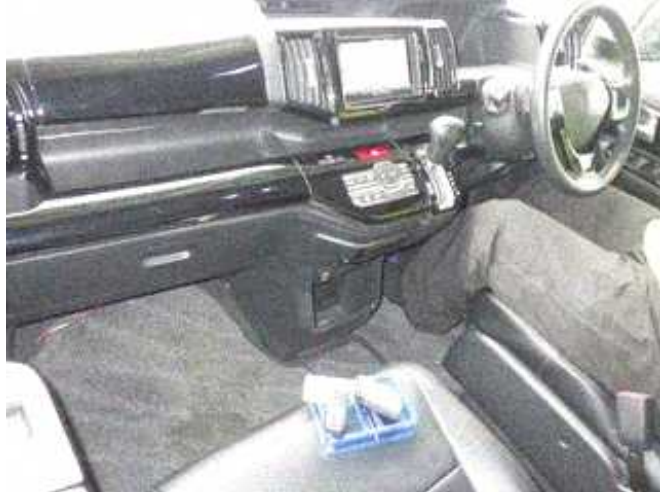
ストックワンプライス掲載票

| セールスポイント | 特記事項・不具合箇所 |
|---|---|
| ★純正ナビ★TV (フルセグ)<br>★両側パワースライドドア<br>★バックモニター★ETC<br>★スマートキー<br>★社外アルミホイール<br>★フリップダウンモニター | シートカバー付<br>スタッドレスタイヤ<br>内装汚れ<br>内張り傷<br>シート擦れ<br>ハンドルすれ<br>カーペットすれ |
